BURLINGTON NORTHERN SANTA FE RAILROAD,
CAJON SUBDIVISION , STRUCTURE 58.1X
Between Cajon Summit and Keenbrook
Devore vicinity
San Bernardino County
California

Burlington Northern Santa Fe Railroad, Cajon Subdivision,
Structure No. 58.1X

HAER No. CA-2259-C

Location: BNSF Railway Company (BNSF) Railroad Structure No. 58.1X, a reinforced-concrete pipe culvert, is located at Milepost 58.1X on Main Track 1, Devore vicinity, San Bernardino County, California. The culvert is bounded by the Union Pacific Railroad to the north and BNSF Main Track 2 to the south.

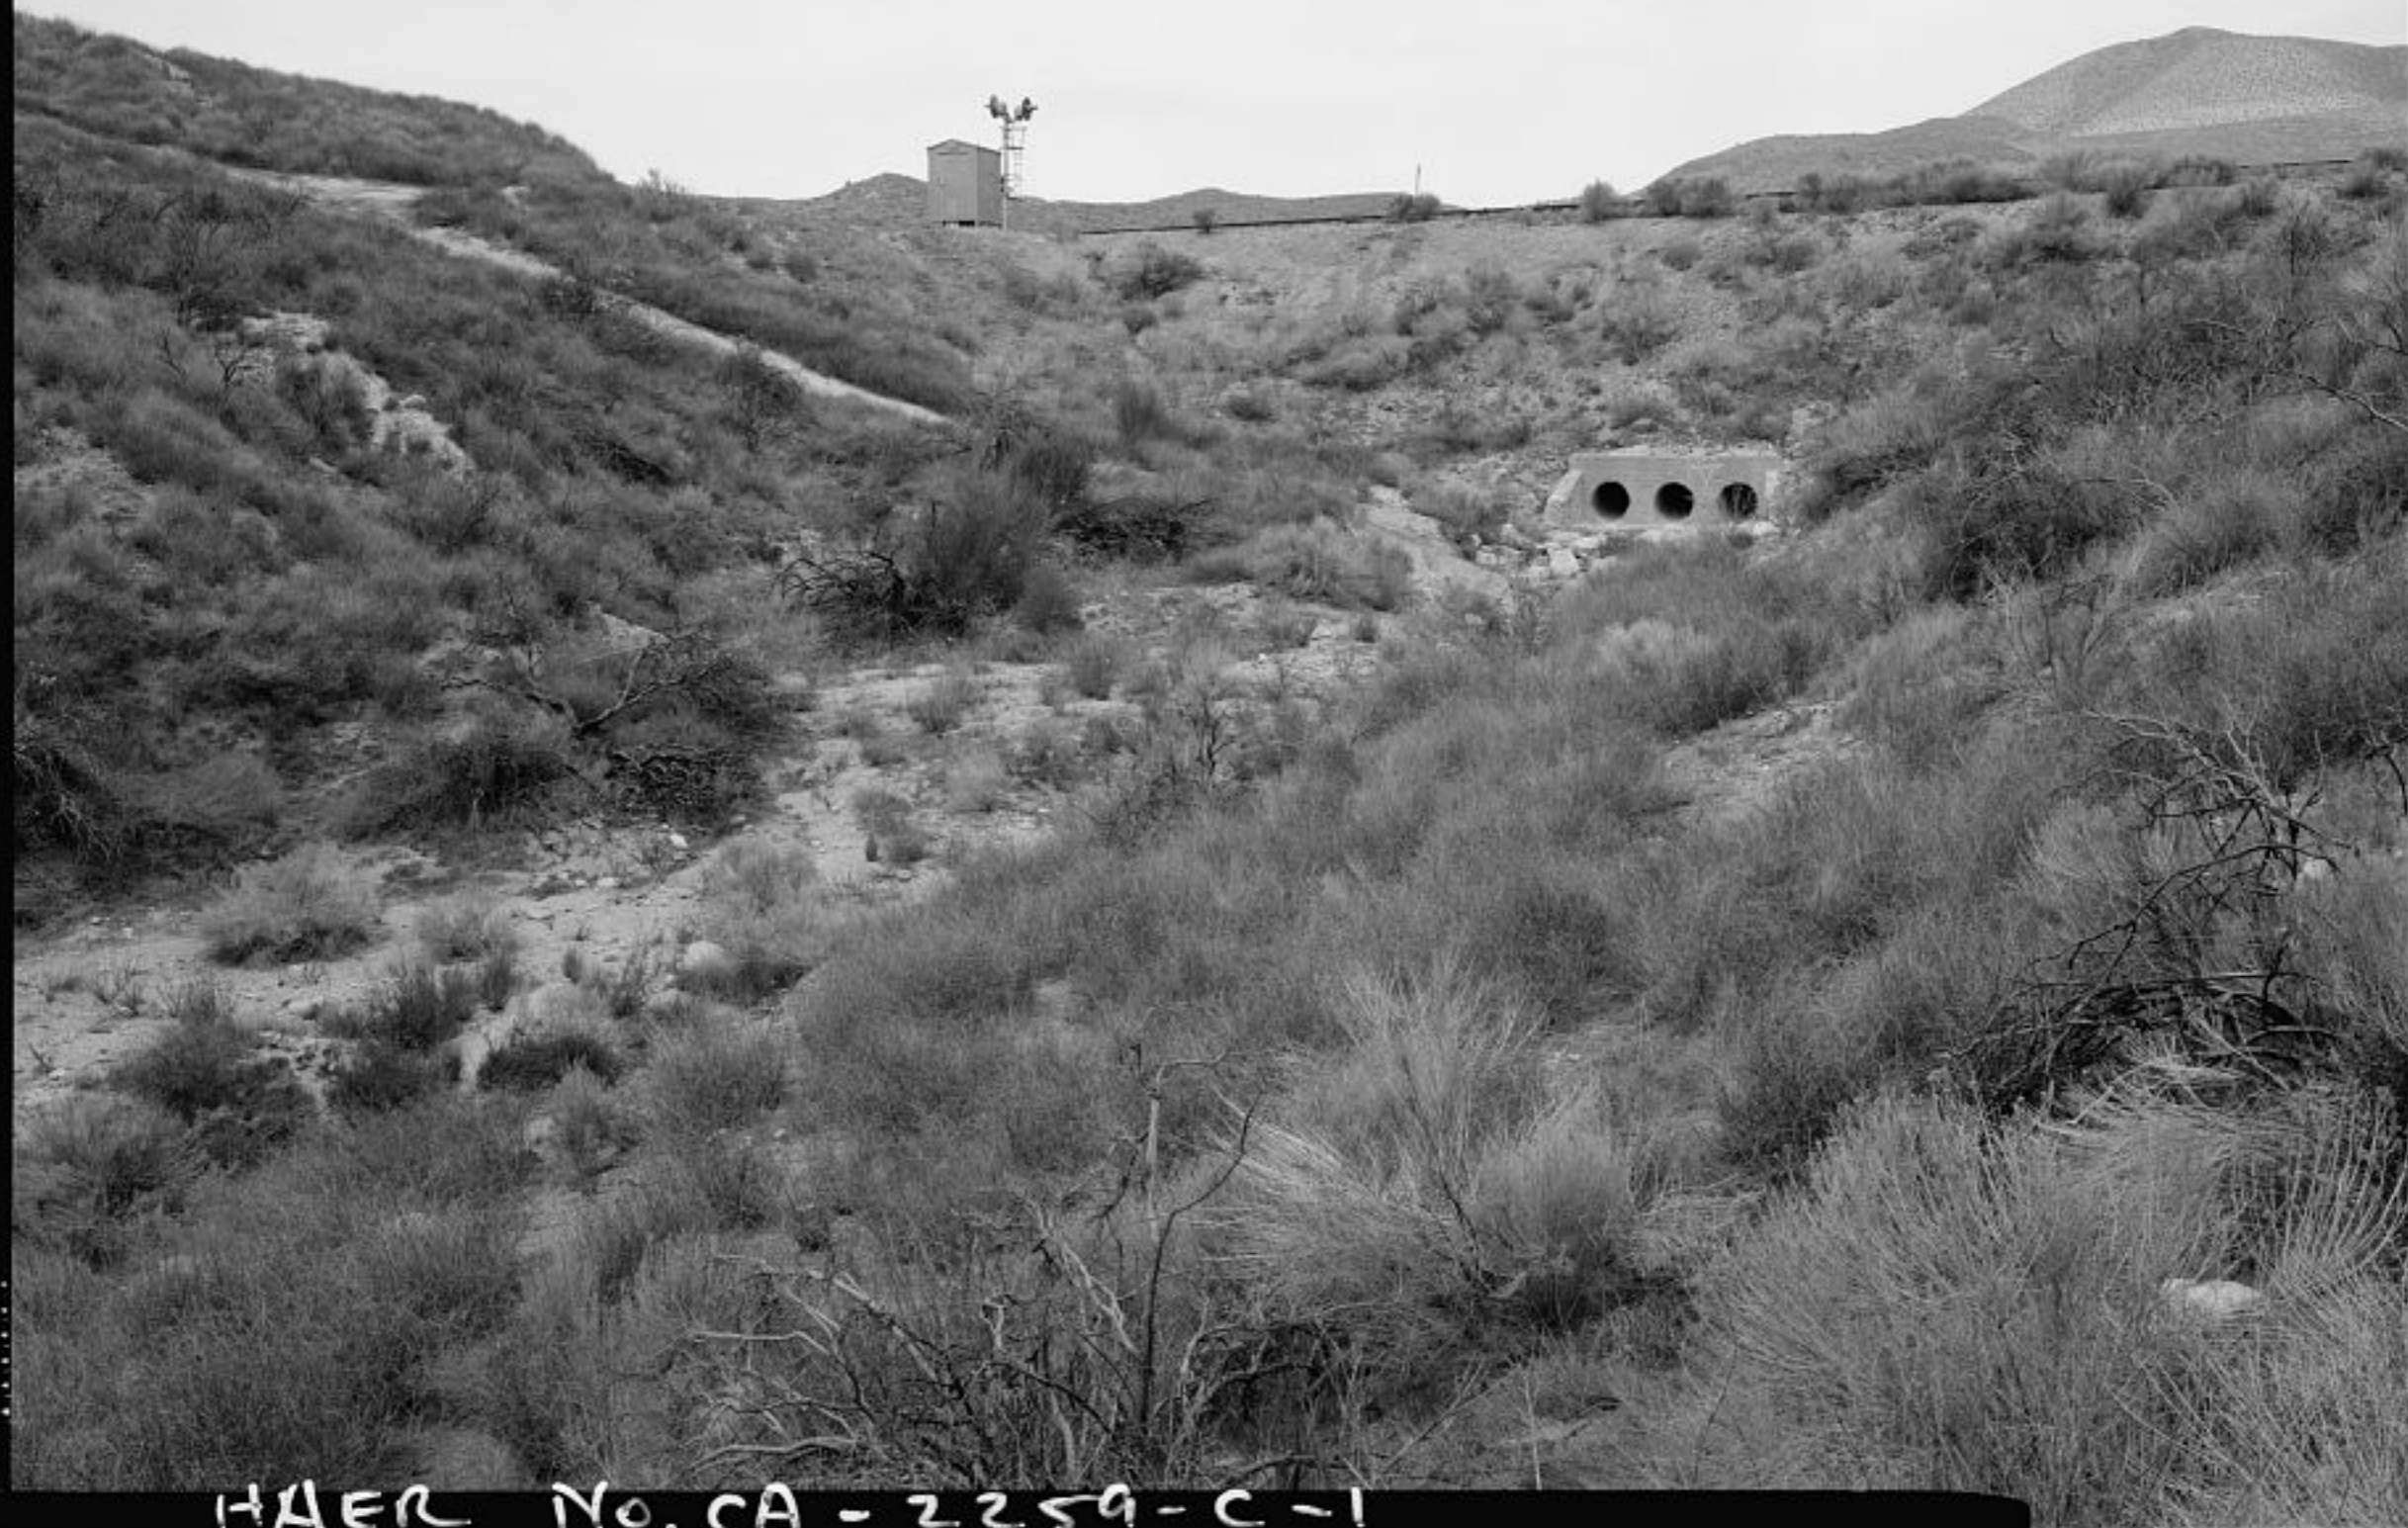
HAER No. CA-2259-C-1

- CA-2259-C-1 CONTEXT VIEW, SHOWING THREE REINFORCED-CONCRETE PIPE OPENINGS
EMPTYING INTO A GULLY. [19]
- CA-2259-C-2 CULVERT INLET SHOWING THREE CORRUGATED METAL STAND PIPES.
VIEW TO THE SOUTHWEST. [18]
- CA-2259-C-3 CULVERT OUTLET. [20]
- CA-2259-C-4 DETAIL OF WING WALL ON OUTLET SIDE OF CULVERT. NOTE THE
INCLUSIONS IN THE CONCRETE. OBLIQUE VIEW TO THE SOUTH-
SOUTHWEST. [21]
